Manhole Inspection Summary

Manhole # S33E__038MH

Insp Date: **8/27/08 11:29 AM**

Location Address: **127 n howard st**

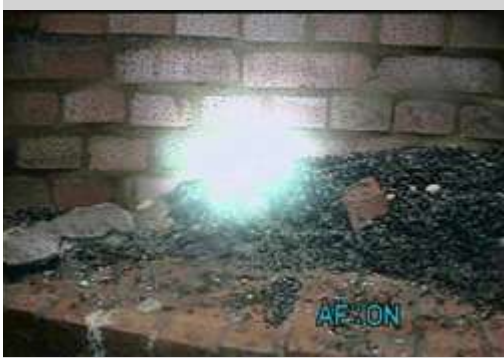
Defect 2

bench debris

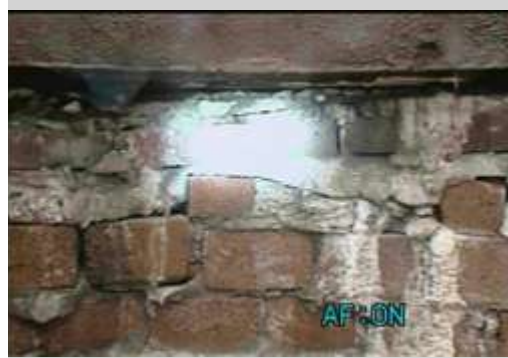
Defect 1

Condition: ☐ Sound ☒ **Cracked** ☐ Root Intrusion ☐ Loose Brick ☒ **Deteriorated**

chimney crack, deteriorated, frame adj

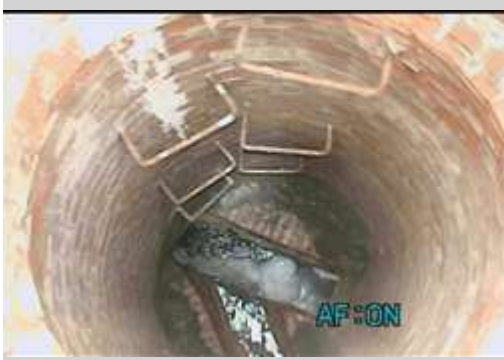
Count: **6** Missing: **0** ☒ **Corroded**

steps

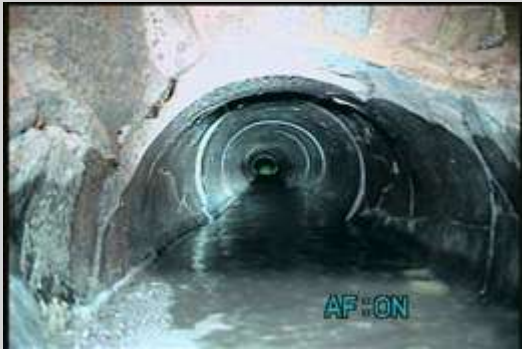
12 O'Clock Outflow

15 in. Circular Gravity Sewer
Pipe Out @ 12 O'Clock

Pipe Material: **Clay** ☐ Pipe Lined

Invert Depth: **14.00** (ft.) Flow Characteristics: **Fast**

Infiltration: **None** Pipe Seal Cond: **Unknown**

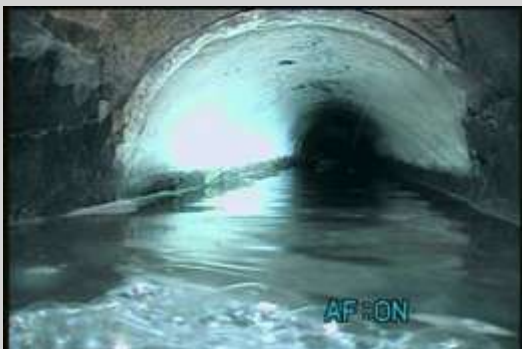
6 O'Clock Inflow

15 in. Circular Gravity Sewer
Pipe In @ 6 O'Clock

Pipe Material: **Clay** ☐ Pipe Lined

Invert Depth: **13.83** (ft.) Flow Characteristics: **Slow**

Infiltration: **None** Pipe Seal Cond: **Unknown**

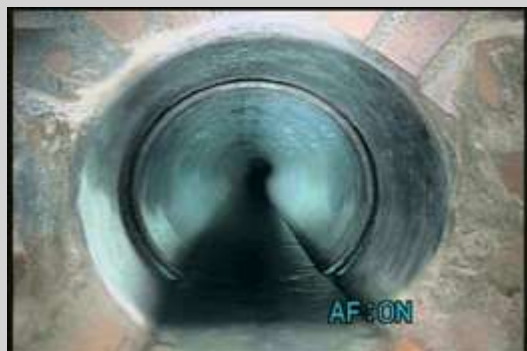
7 O'Clock Inflow

15 in. Circular Gravity Sewer
Pipe In @ 7 O'Clock

Pipe Material: **Clay** ☐ Pipe Lined

Invert Depth: **13.16** (ft.) Flow Characteristics: **Fast**

Infiltration: **None** Pipe Seal Cond: **Unknown**
